Re: IRAM Completion Letter, DU-6  
Willamette Cove Upland Facility  
Portland, Oregon  
ECSI No. 2066  
1056-05

This letter presents the results of the Decision Unit 6 (DU-6) Interim Remedial Action Measure (IRAM) activities completed on July 21, 2014 for the Willamette Cove Upland Facility (the Facility; Figures 1 and 2) in the St. Johns area of Portland, Oregon. Work at the Facility was conducted under Voluntary Agreement EC-NWR-00-26 between the Port of Portland (Port), Metro, and the Oregon Department of Environmental Quality (DEQ).

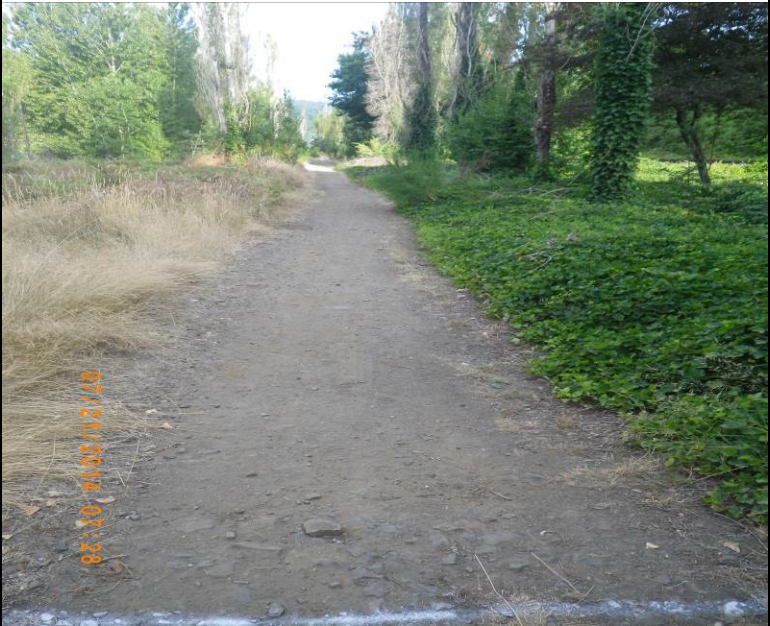
<b>Photo No:</b> 1	
<b>Photo Date:</b> 7/21/14

<b>Orientation:</b> West	
<b>Description:</b>  Targeted portion of pathway prior to capping.	
<b>Photo No:</b> 2

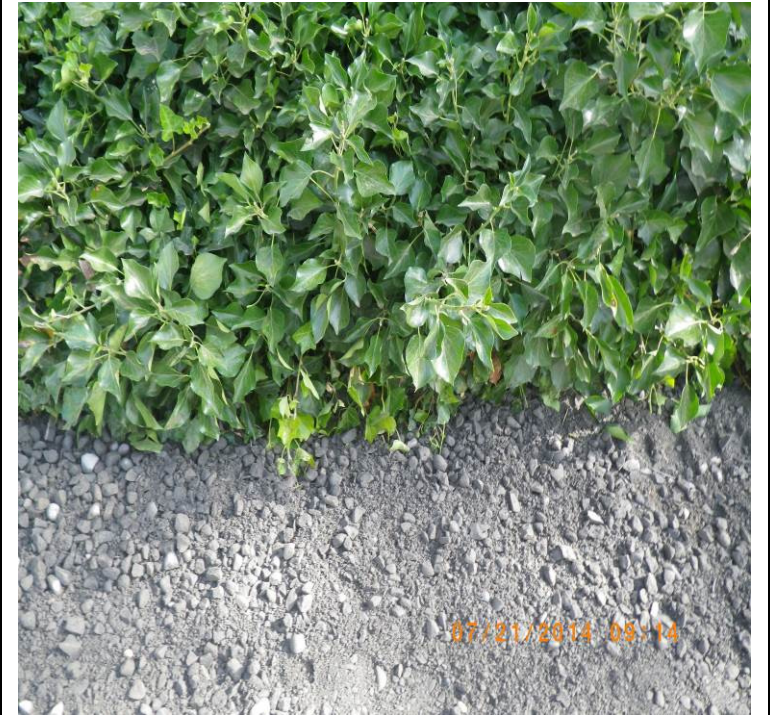
<b>Photo Date:</b> 7/21/14	
<b>Orientation:</b> South	
<b>Description:</b>  Gravel cap placed to the edge of vegetation.
